Lower Colorado River Multi-Species Conservation Program

Hart Mine Marsh

2014 Annual Report

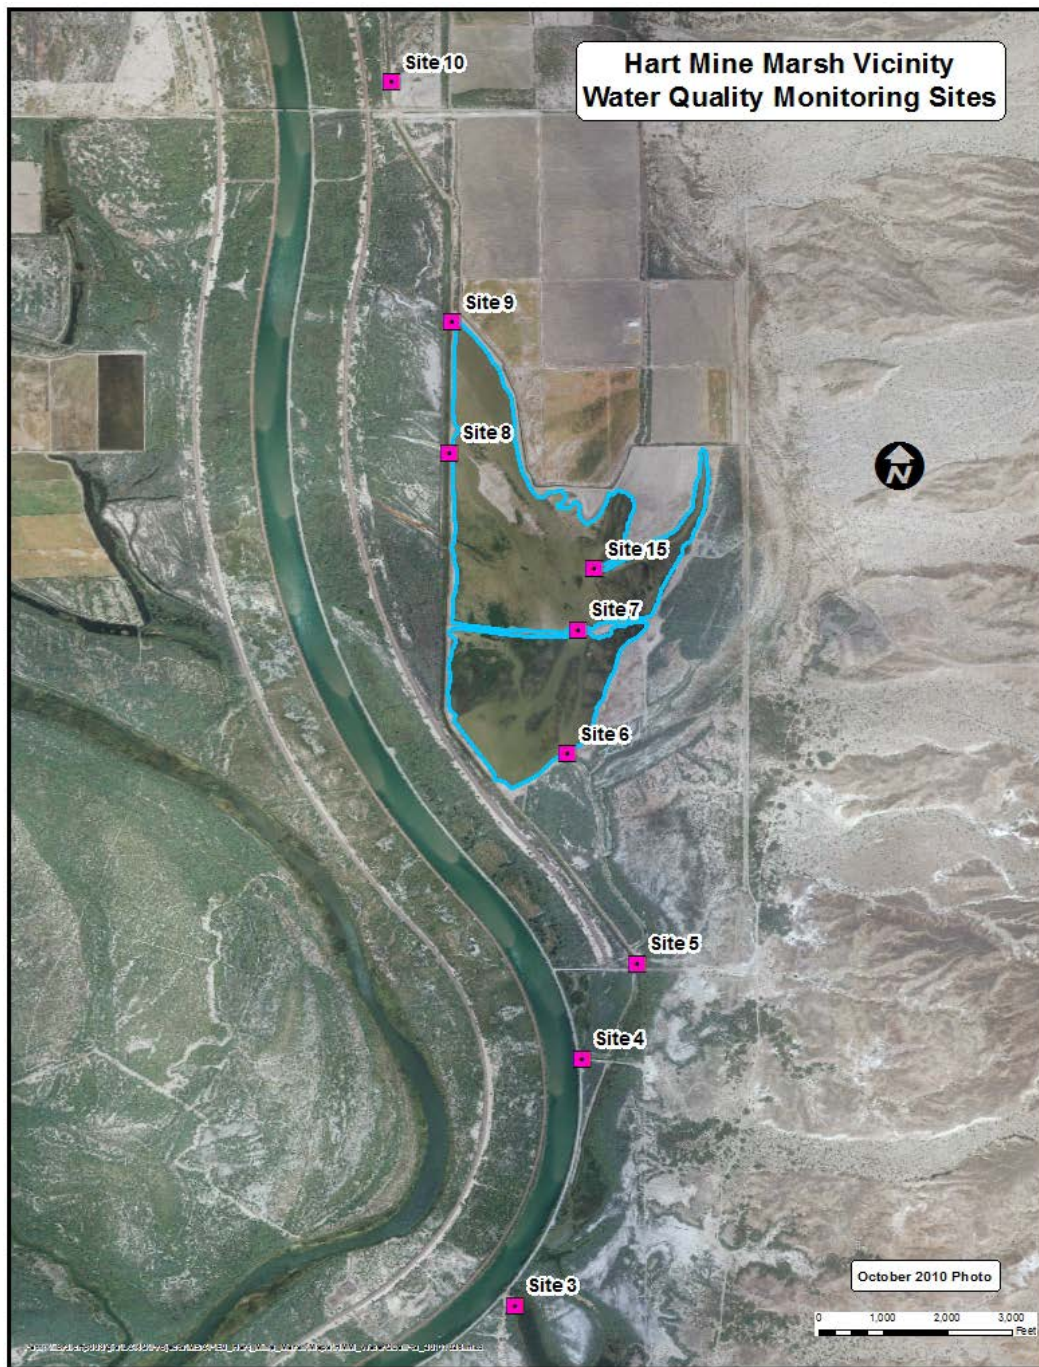
Figure 4.—HMM water quality monitoring locations.

The USFWS is responsible for monitoring and reporting on many abiotic parameters of the site as part of the interagency agreement with Reclamation. The Cibola NWR continued monthly water quality monitoring at specific points throughout the marsh. Water quality parameters, including pH, dissolved oxygen, and specific conductivity (as a measurement of total salinity), were measured throughout the fiscal year. Figure 4 shows the locations (sites) where water quality parameters are measured and collected in the vicinity of HMM.
